Positive Investigation Methodology

31 October 2018

Case Study 3: Laverton Chlorine Facility, Victoria, March 2018

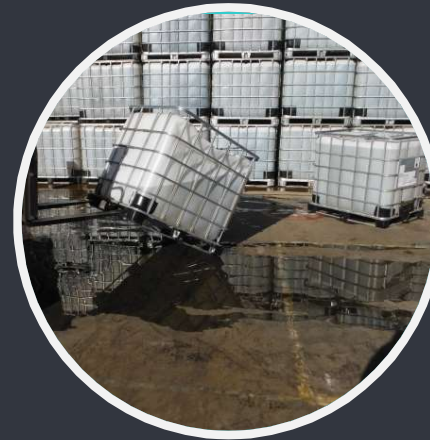
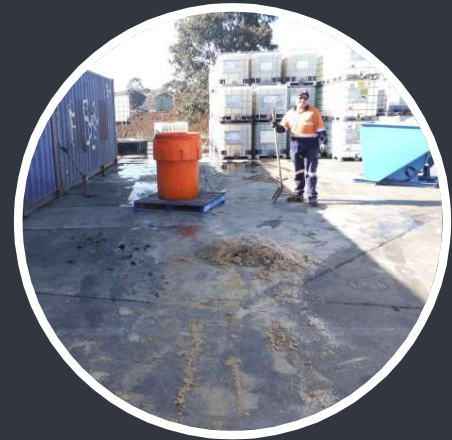
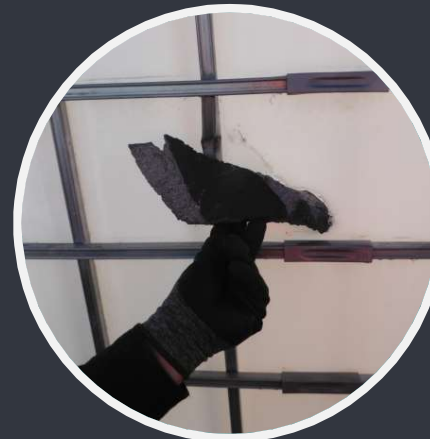
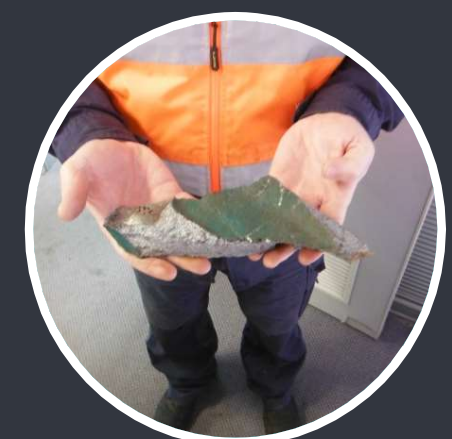
- At the Laverton Warehouse site – where a metal recycler from the site next door ejected a 2kg piece of metal which hit a 1000L container of water treatment chemical causing it to rupture.
- The metal recycler was operating a few metres from the boundary, to break up machinery pieces. As part of this process, the ejected piece went over the boundary fence and into the IBC.
- An Ixom worker who was driving a forklift heard the sound and saw the liquid from the IBC flowing onto the ground.

- There was the potential for a serious injury, even a potential fatality, which could have occurred given the force and speed of the projectile.

- It is very important to monitor neighbouring activities, when the nature of their operations can be high risk and impact on you without warning.

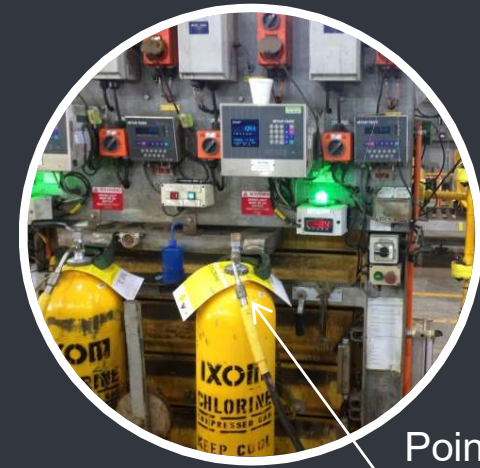
Point of leak

- Whilst disconnecting a filled chlorine cylinder, there was a small release of chlorine from the filling hose. No injuries were sustained.
- He had opened the degas valve on the north filling point and missed opening the south degas valve. The technician also did not see the green indicator was off showing the hose was not under extraction.
- The gas sensor was triggered and the packing shed personnel evacuated on the alarm.
- The building extraction system operated effectively and the area was then checked and made safe.

- The technician had a process of doing the task whereby he would stand at the side of the cylinder and angle the hose away from his body. These were personal control measures implemented by an experienced worker.

- There were several systems including the chlorine filling station design and operation, as well as operator techniques which worked to mitigate the incident.
- Ixom had the opportunity to learn from the controls that were implemented by an experienced worker.
